MEMORANDUM

September 20, 1990

**SUBJECT:** Request for a Removal Action at the Dugan & Helterbrand Company Site, Marshfield, Missouri

**CERCLIS ID #:** MOD086919248

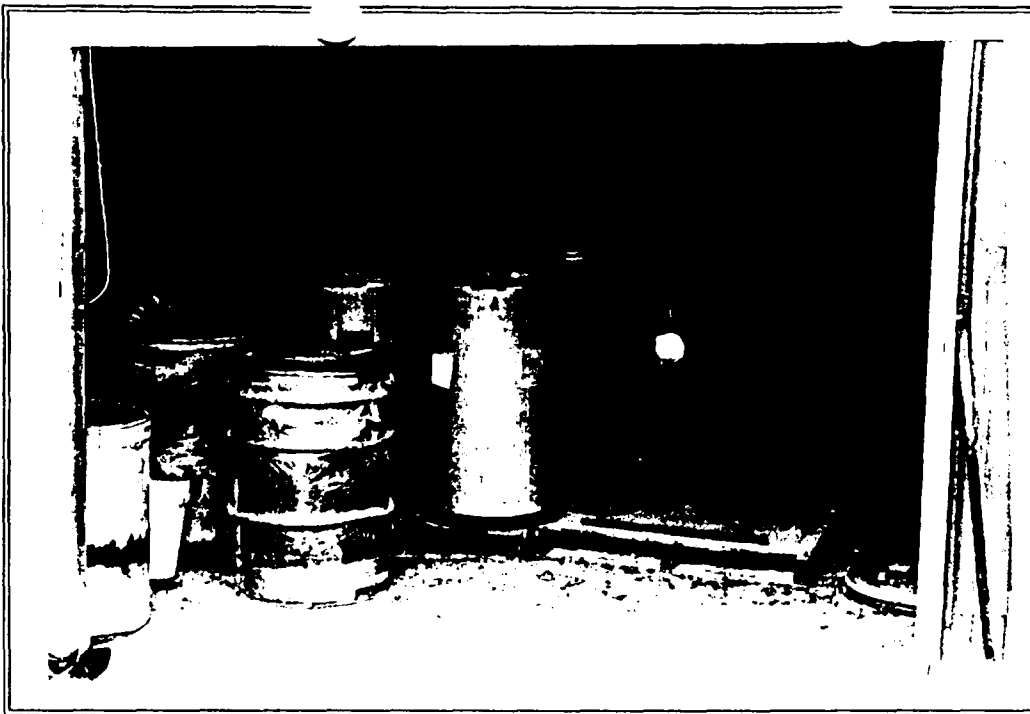
PHOTO NO.: 15

SUBJECT: Fiber drums of cyanide salt residues, sludges and solids.

e. Cyanide bath residues, sludges, and solids will be containerized and disposed of.

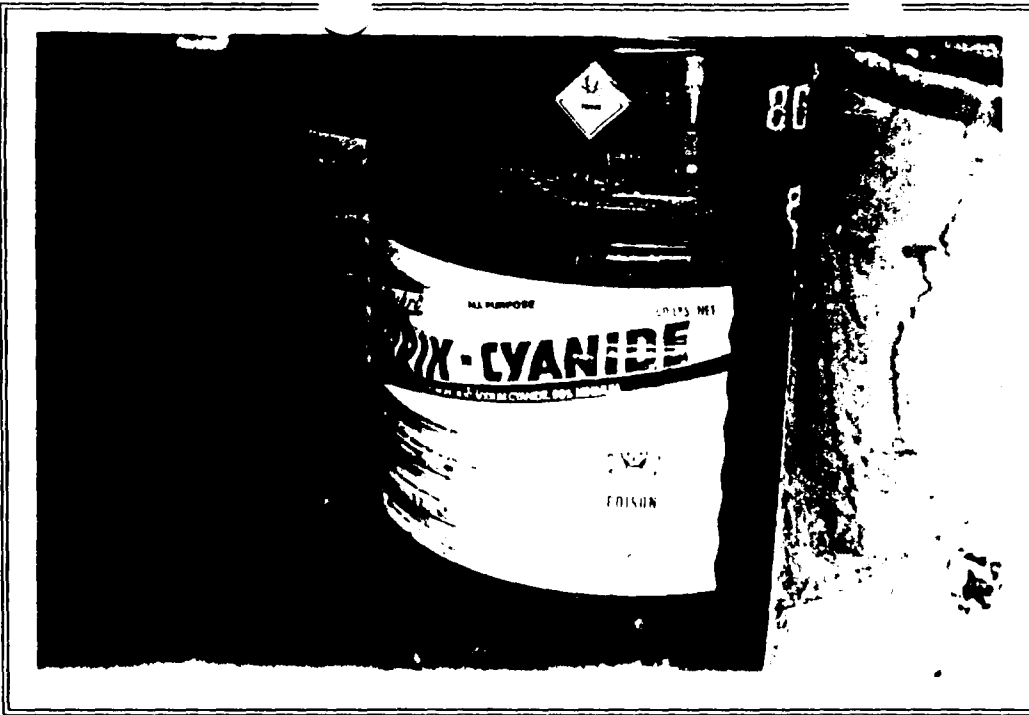
PHOTO NO.: 17

SUBJECT: Drum of sodium cyanide.

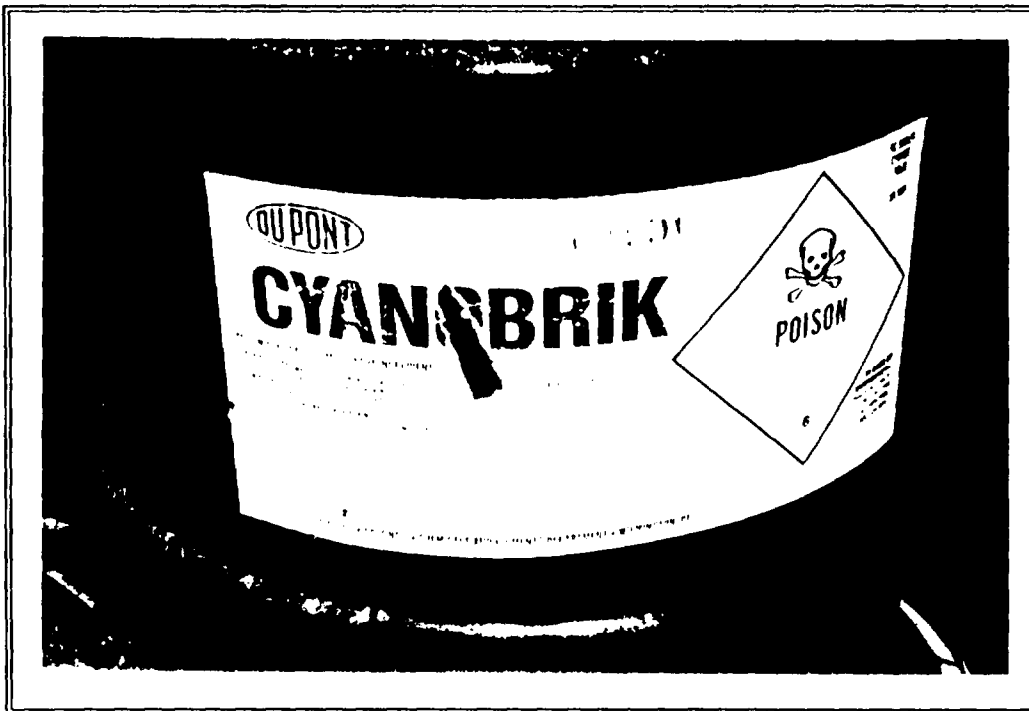
PHOTO NO.: 18

SUBJECT: Drum of sodium cyanide.

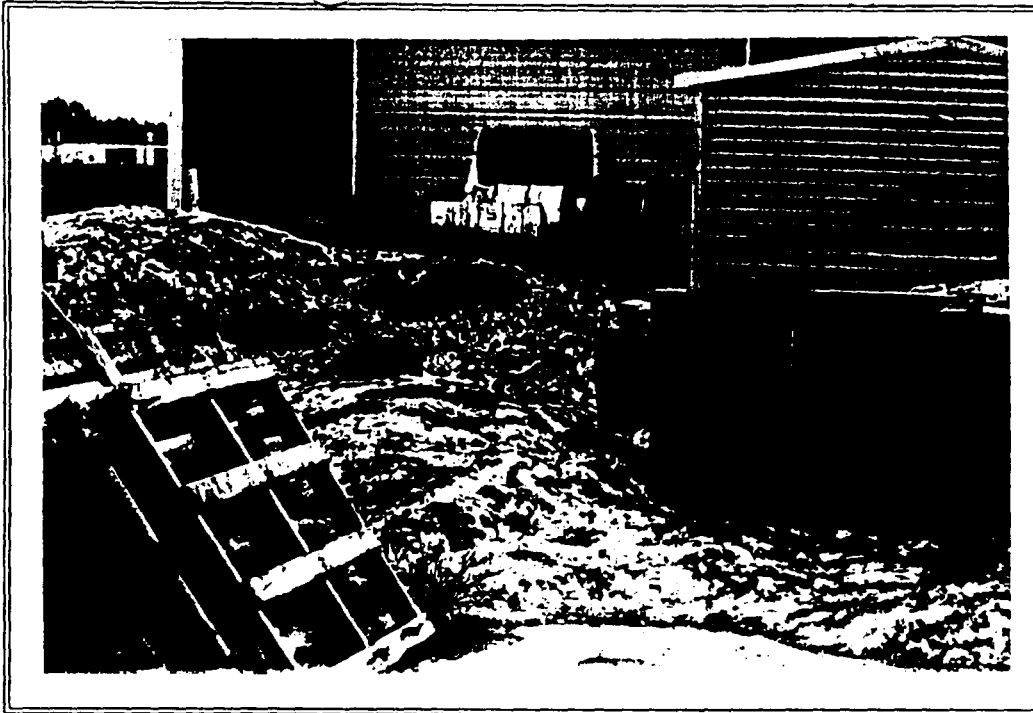
PHOTO NO.: 21

SUBJECT: Waste pile of "treated" film chips north of the chemical storage building.
